# **Intel<sup>®</sup> Mobile Celeron<sup>™</sup> Processor Specification Update**

Release Date: November 1999

Order Number: 244444-009

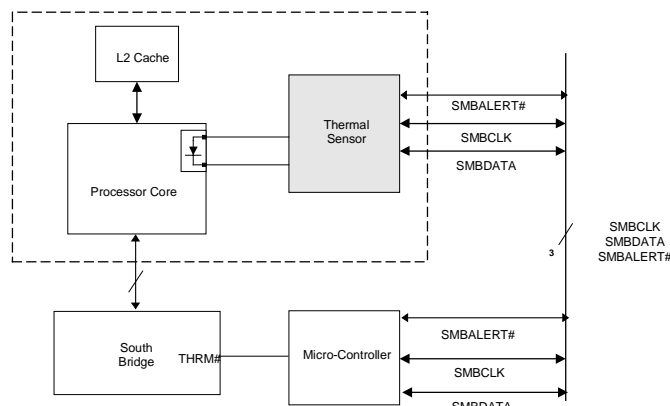
### Figure 1. An Example of Microcontroller Driven Thermal Management

## H29. Thermal Sensor May Assert SMBALERT# Incorrectly

**Problem:** The Intel Celeron Processor Mobile Module has a thermal sensor that monitors the processor core's temperature. Please note that desktop systems could have a similar thermal device. The thermal sensor asserts SMBALERT# if the processor temperature exceeds the temperature limits set in the Alarm Threshold Registers (T<sub>HIGH</sub>, T<sub>LOW</sub>). It also sets the corresponding Status Register bits to identify the cause of the interrupt. Figure 1 gives one example of the how the SMBALERT# signal could be used in a system.

**Implication:** There is no system impact from this erratum if temperature polling is used for processor thermal management. If the SMABLER# interrupt is employed to manage processor thermal sensing, then servicing the false interrupt may result in premature system action depending on the software and hardware implementations used. The rate of the false interrupts is less than the auto-convert rate of the thermal sensor.

**Workaround:** Three different (mutually exclusive) workarounds are possible:

1. Before servicing an interrupt from the thermal sensor, read and compare the processor thermal reading with the threshold limits ( $T_{HIGH}$  or  $T_{LOW}$ ). Figures 2 and 3 provide basic flowcharts for the implementation of this workaround in an interrupt driven system.
2. If the firmware implemented polls the Status Register only, then before taking any action, re-read the temperature register and do a comparison with the alarm threshold limits ( $T_{HIGH}$  or  $T_{LOW}$ ) to determine if the value is actually still within the temperature window.
3. Use a temperature polling scheme to monitor the processor temperature.

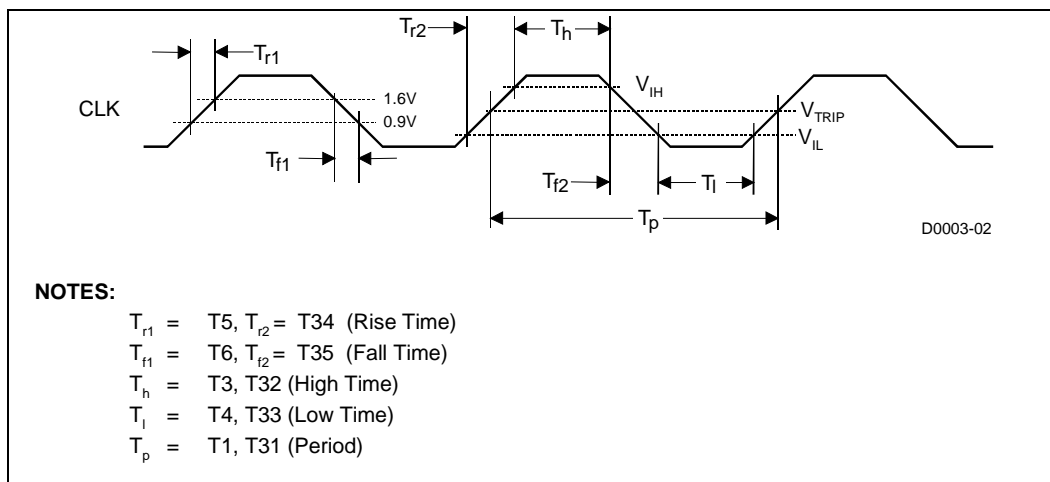
Figure 3.3 Generic Clock Waveform

Figure 3.3 in the *Intel® Mobile Celeron™ Processor in  $\mu$ PGA1 and BGA1 Packages at 366 MHz, 333 MHz, 300 MHz, and 266 MHz* datasheet (Order Number 245112-003) has been updated. The following figure is to replace the one in the above document.
